# PROBLEM *Solver*<sup>™</sup> BULLETIN

## Upper Ball Joint Premature Wear

GM Full Size Passenger  
Cars, Vans and  
S10 Series Light Trucks

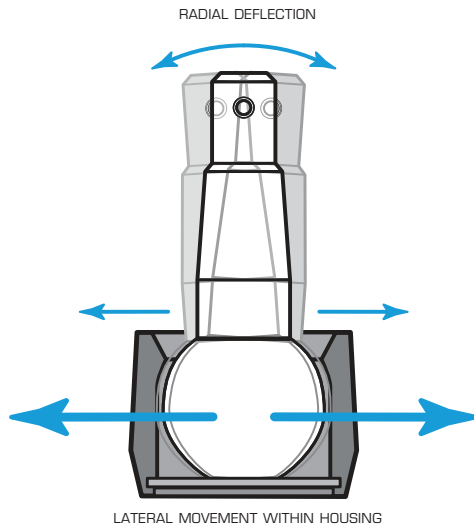
#### OE upper ball joint premature wear

- Several GM cars and trucks exhibit high lateral loads in turns. These high loads are transferred into the upper ball joints, causing excessive radial deflection. Radial deflection (sideways "play" or movement) leads to lateral movement of the ball stud within the housing, creating stress and wear on the bearing surfaces.
