PROBLEM Solver™ BULLETIN

Premature Ball Joint Wear

1999-2006 GM Trucks

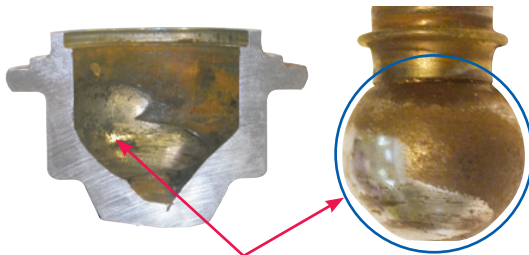
Lower ball joint experiences premature wear

- Original equipment stud ball diameter and OE-style polymer bearing do not provide sufficient load-carrying capability, especially in rough service conditions.
- Load stress and intrusion quickly erode the bearing surface.

NOTE: Distressed OE style polymer bearing due to rough service conditions.

OE part measured 0.080" of play due to bearing failure. As a result, the non-hardened housing and ball stud components wear into each other.

MOOG® K6693 Lower Ball Joint

- The MOOG K6693 lower ball joint was designed with an oversized stud ball diameter that maximizes ball-to-bearing contact.
- Two powdered-metal “gusher” bearings with grease grooves provide the most durable wear surface available.
- The combination of two powdered-metal bearings and an oversized stud ball diameter provides superior load-carrying capability, increased durability and extended service life.
