# PROBLEM Solver™ BULLETIN

**BULLETIN: 25668**

**Premature wear  
resulting in possible  
ball joint separation**  
1995–2002  
Ford, Mercury, Lincoln

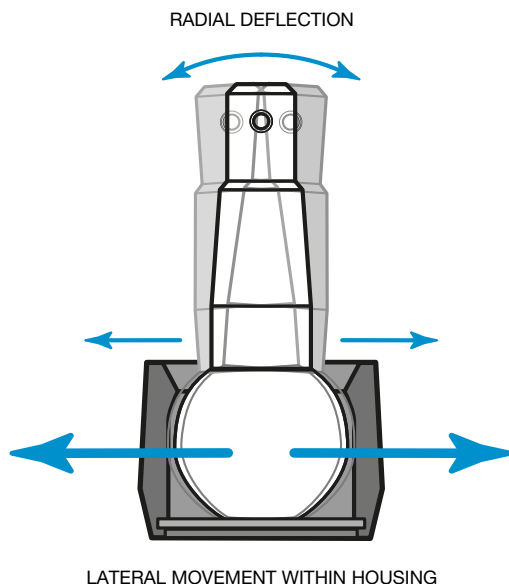
### Premature wear resulting in possible ball joint separation

- Punishing wear and tear experienced in Police and taxi fleet environments can cause excessive wear in OE and OE replacement ball joints which could lead to joint separation.

Year	Make/Model*	Replacement Part No.
'95-'02	Ford Crown Victoria Mercury Grand Marquis Lincoln Town Car	K8685
