Problem Solver Bulletin: 216004

K3185 LOWER BALL JOINT

1999-2015 JEEP VEHICLES

LOWER BALL JOINT FAILURE, DIFFICULT TO SERVICE

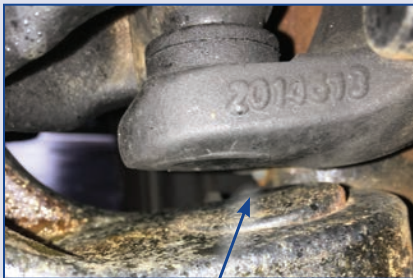
The OE front lower ball joint is not serviceable and is prone to premature failure. The proximity of the axleshaft to the lower ball joint prevents the inclusion of a typical grease fitting. Also, its non-serviceable design allows dirt and other contaminants to remain in the ball joint, causing wear.

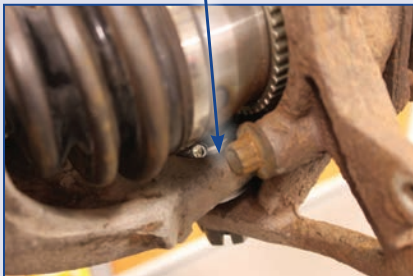
NOTE TIGHT CLEARANCES

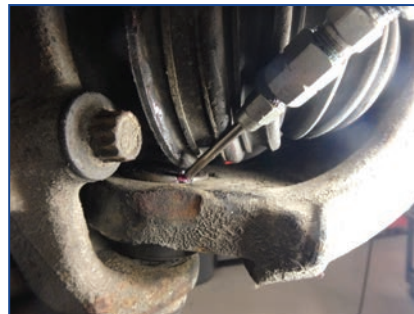
A needle nozzle adaptor can be used to grease this MOOG ball joint.

The MOOG® K3185 lower ball joint features a flush, angled grease passage that allows the ball joint to be positioned for easy access for greasing with a needle nozzle adaptor such as the Lincoln #5803 or similar.
