PROBLEM *Solver*[™] BULLETIN

Premature Lower Ball Joint Failure

General Motors
S-10 (T) Series
Light Trucks and SUVs

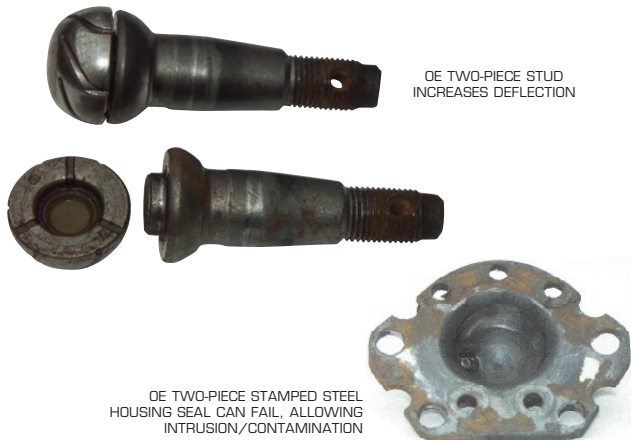
Lower ball joints experiencing premature wear

Today's SUVs and light trucks are equipped with large wheel and tire assemblies that result in taller ride heights. This raises the vehicle's center of gravity, creating high lateral loads in turns. The high loads are transferred into the ball joints, causing radial deflection (sideways "play" or movement), stress and wear on bearing surfaces.

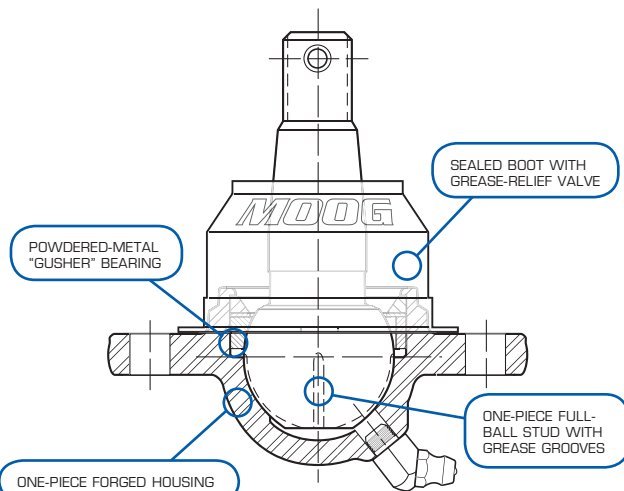
MOOG® K5289/K5335 Lower Ball Joint

- Features a newly designed forged housing with superior fine-grain metallurgical structure for additional strength and durability.
- NASCAR®-proven split-bearing technology eliminates excessive radial deflection often experienced with high lateral loads. The ball joint assembly maintains maximum ball-to-bearing contact for greater load-carrying capability.
- Belleville washer preload provides lower stud articulation torque with minimal axial clearance.
- Hardened powdered-metal bearings and a hardened full-ball stud with grease grooves provide the most durable wear surface available, for extended service life.
- A flange style sealed boot equipped with a special grease-relief valve keeps contamination out and provides a serviceable, sealed environment.
