REAR UPPER BALL JOINT

1996-2005 **FORD TAURUS** WAGON, MERCURY SABLE WAGON

THE PROBLEM SOLVER®

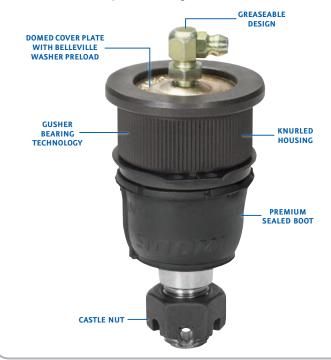
MOOG® Problem Solver® K500208 upper ball joint

MOOG® Problem Solver® ball joint K500208 is the perfect replacement for the failure-prone ball joint. Its knurled housing enables it to fit securely into the spindle. Its design, which incorporates an all-metal gusher bearing and full-ball stud, is both smooth and durable.

- All-metal "gusher" bearing design provides strength and allows lubricant to penetrate bearing surfaces for longer life.
- Greaseable design flushes contamination and keeps part lubricated.
- MOOG patented domed cover plate and Belleville washer ensure proper preload and consistent socket torque for the life of the part.
- Metal stud with full-ball configuration provides smooth, even rotational movement.
- MOOG "grease release" polychloroprene boot lasts longer and directs contaminants out of the socket and away from brake components during lubrication.
